## National Transportation Safety Board Aviation Accident Preliminary Report

| <b>Location:</b> | Grant, NE | <b>Accident Number:</b> | CEN20LA306 |
| <b>Date &amp; Time:</b> | July 25, 2020, 11:36 Local | <b>Registration:</b> | N502KJ |
| <b>Aircraft:</b> | Air Tractor AT502 | <b>Injuries:</b> | 1 Fatal |

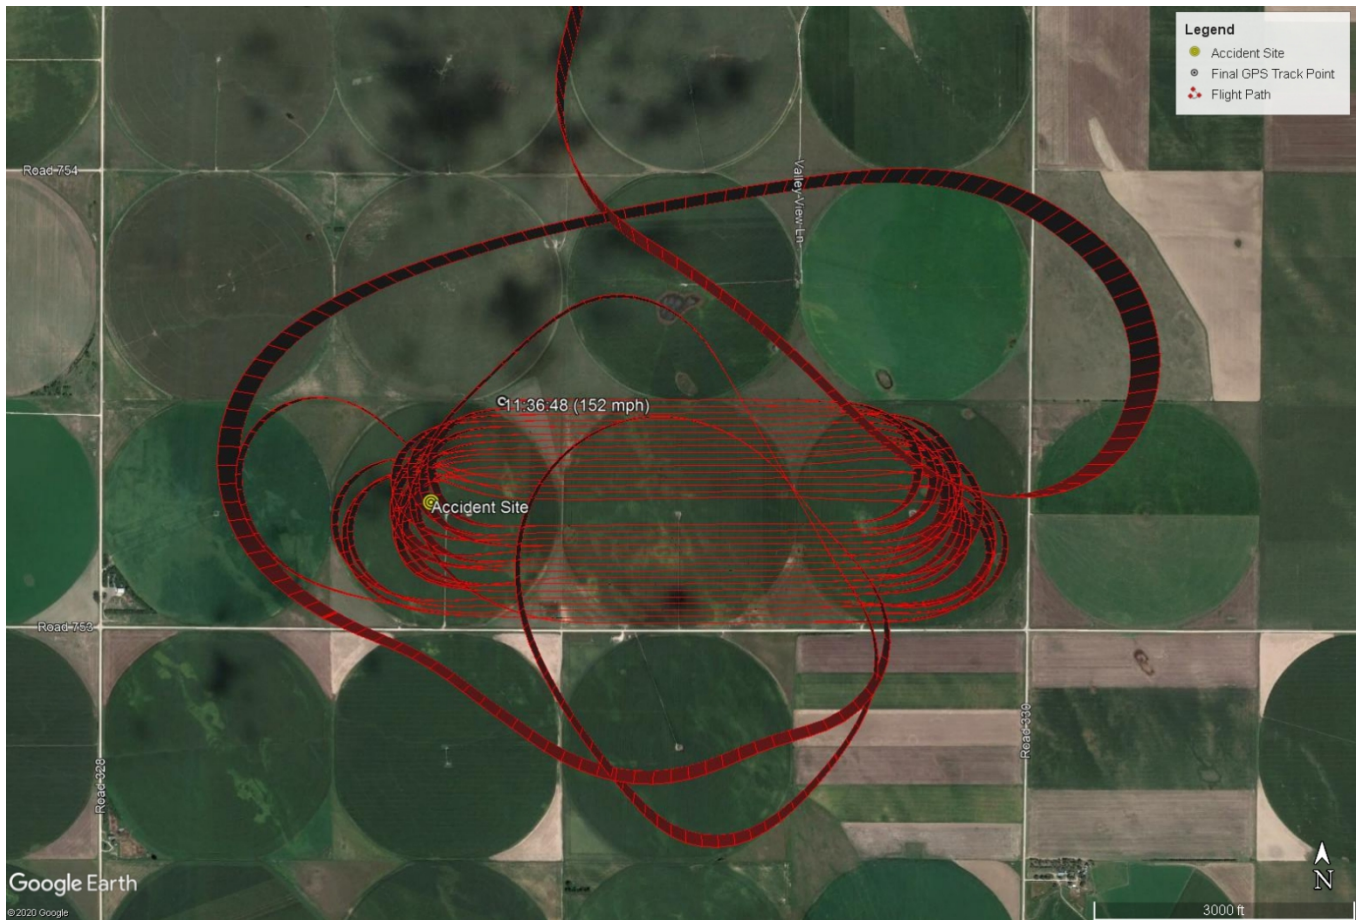
Figure 1: Plot of GPS Track Data

According to the recovered track data (Figure 1), the pilot entered a climbing left turn after each spray pass, with the airplane routinely climbing 400-500 ft during a course reversal turn. The airplane's average ground speed during the spray passes ranged between 155 and 165 mph, and the ground speed decreased to between 104 and 120 mph during each course reversal turn (Figure 2). At 1136:48, the final recorded track point showed the airplane climbing on a west heading near the end of a spray pass at the north edge of the field. The airplane's final ground speed and altitude above ground level (agl) were 152 mph and 70 ft agl, respectively. According to a Satloc representative, the GPS guidance system had a 6 second delay between data acquisition and when the data was saved to non-volatile memory. The final position report was located about ¼ mile northeast of the accident site.

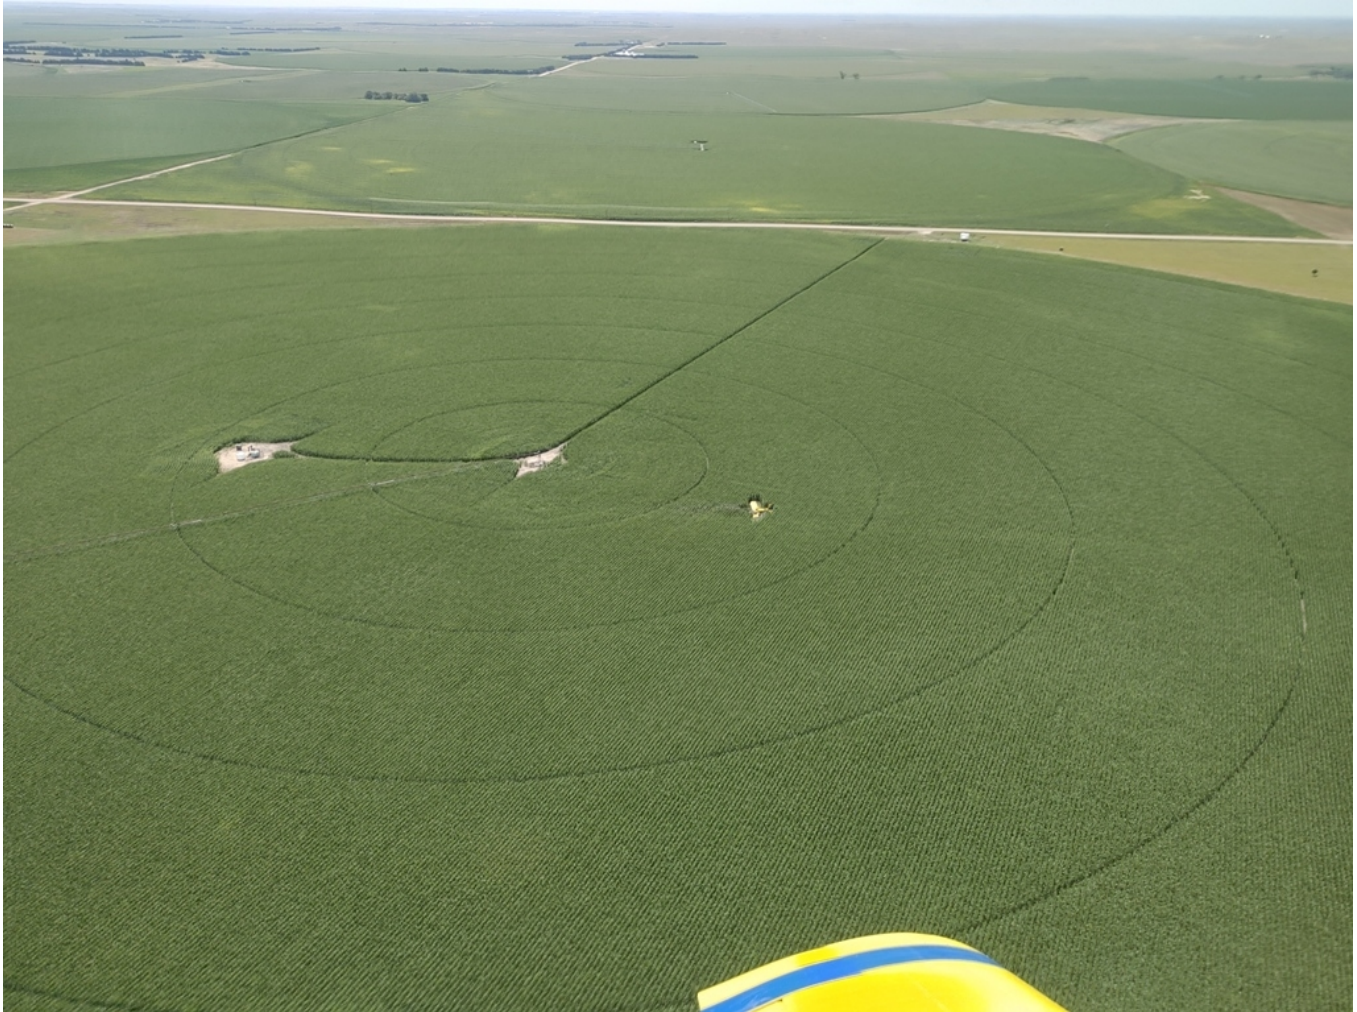
Figure 3: Aerial Photo Taken of Accident Site

The accident site was in a cornfield located about 8.7 miles south-southeast of GGF. According to a Federal Aviation Administration inspector and an Air Tractor accident investigator who responded to the accident site, the airplane impacted terrain in a nose down pitch attitude. The corn stalks immediately surrounding the accident site exhibited damage consistent with a 45° nose down flight path angle. There were no ground impacts or a discernable debris path preceding the wreckage. The airplane was found upright with significant impact damage to the forward fuselage and the leading edge of both wings.

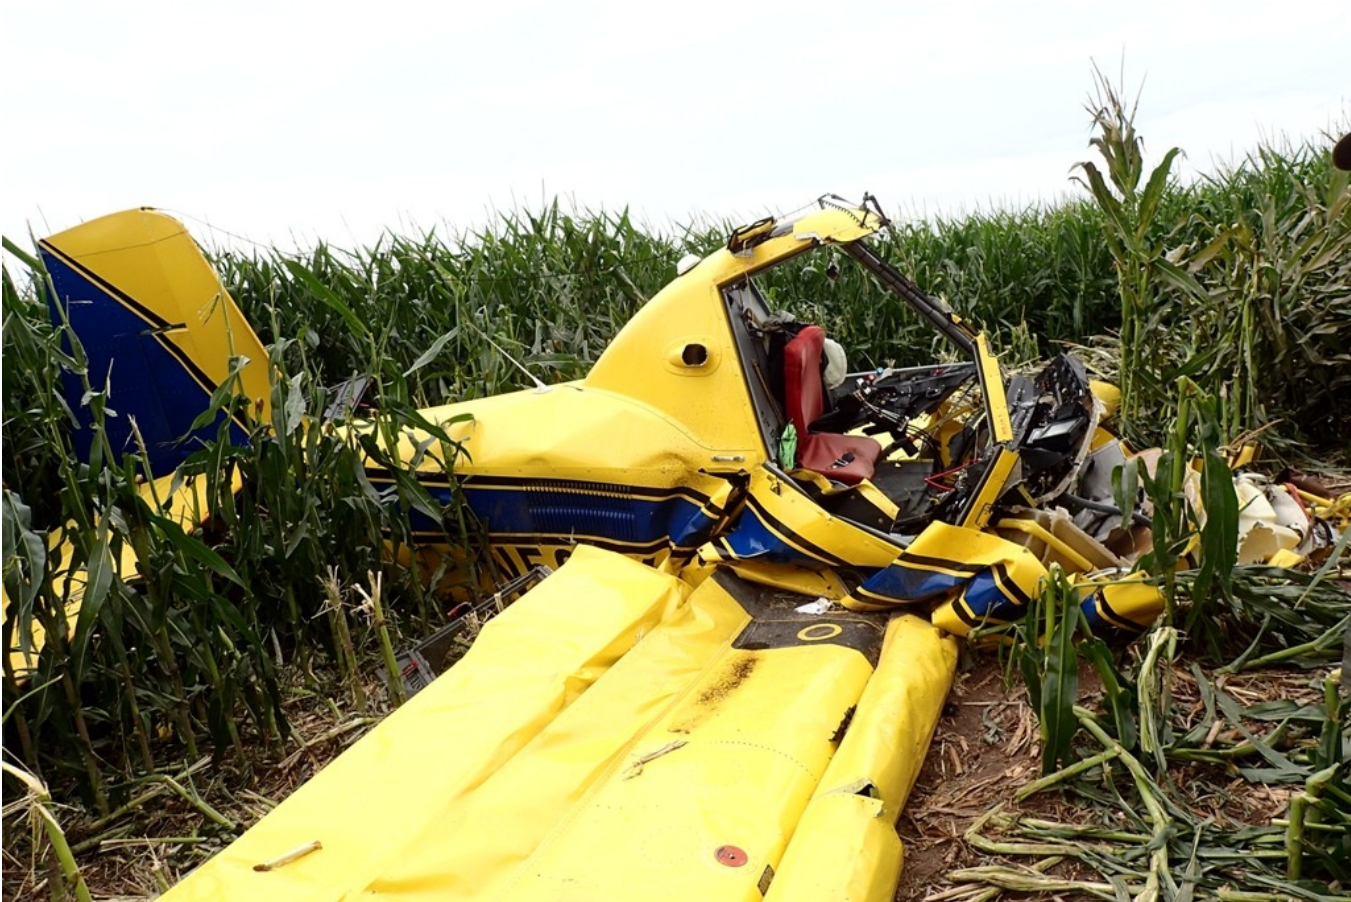
Figure 4: Overview Photo of Main Wreckage at Accident Site

The fuselage was oriented on an east-southeast heading. The aft fuselage and empennage exhibited minor impact-related damage. Both wing fuel tanks had ruptured during impact, and the odor of Jet-A fuel was present at the accident site. Flight control continuity could not be established due to damage; however, all observed separations were consistent with impact-related damage. The flap actuator measured 2.125 inches and was consistent with a 20° flap extension at impact. The aileron drooping system was continuous from the flap torque tube to the aileron bellcrank support assembly. Both landing gear legs had separated from the fuselage during impact. The engine and the propeller were found buried

about 3 ft below ground level. The postaccident examination did not reveal any anomalies that would have precluded normal airplane operation during the flight.
