Aviation Investigation Preliminary Report

Location:	Meadow Grove, NE	Accident Number:	CEN25FA261
Date & Time:	July 19, 2025, 20:50 Local	Registration:	N55161
Aircraft:	Kolb Firestar	Injuries:	1 Fatal
Flight Conducted Under:	Part 91: General aviation - Personal

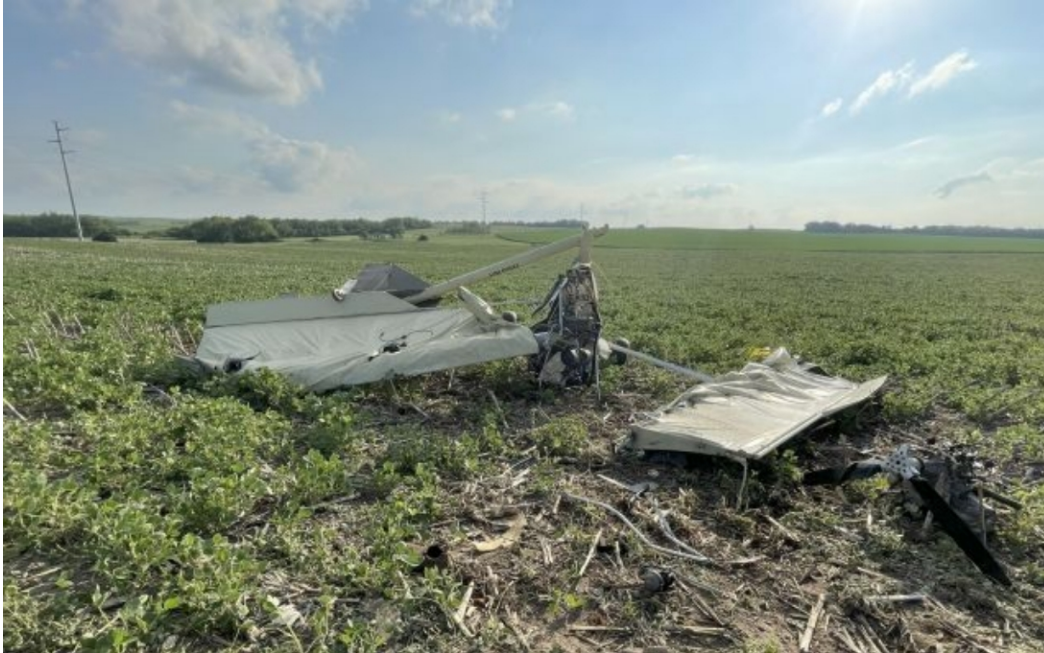
Figure 1 – Accident Site

The accident site was located in a soybean field about 0.3 mile south of the departure airstrip. Initial ground impact was about 50 ft from the wreckage, and the impact path was oriented on a southwest heading. The forward portion of the fuselage was crushed aft, and the cockpit area was compromised. The left wing was separated at the root and retained by the wing strut. The right wing remained attached to the fuselage at the root with the wing strut intact. The tailboom was fractured about 2 ft aft of the fuselage consistent with impact forces. It was retained by the elevator and rudder cables. The empennage remained attached to the tail boom. The upper portion of the vertical stabilizer and rudder were deformed consistent with the impact sequence.
